Portage Creek Sediment Remediation Project Kalamazoo, Michigan

Post-Sediment Removal Structure Feature Assessment Removal Area SA5-A

F&V Project Number: 809930
August, 2013

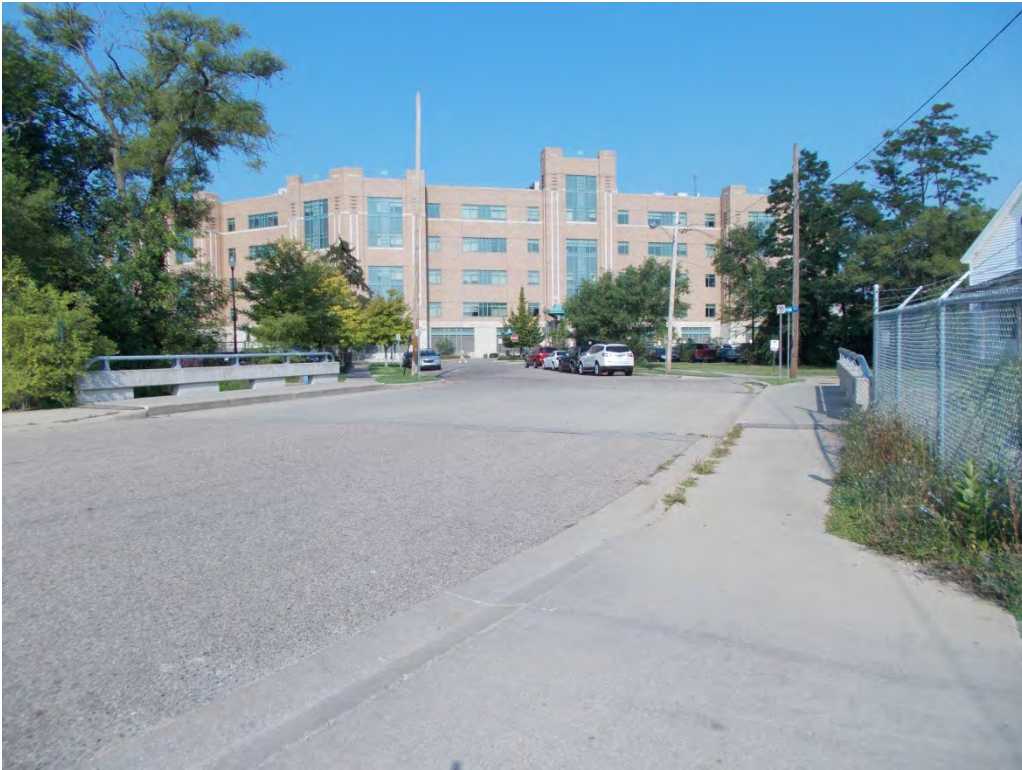
- There are several cracked sections of concrete sidewalk in the northeast approach. The scratches on the surface appear to indicate the damage is related to sediment removal. Three sections appear to be marked for replacement, which is recommended.
- Aside from the sidewalk, the structure does not appear to have been impacted during sediment removal.

Structure viewed from the northeast approach area

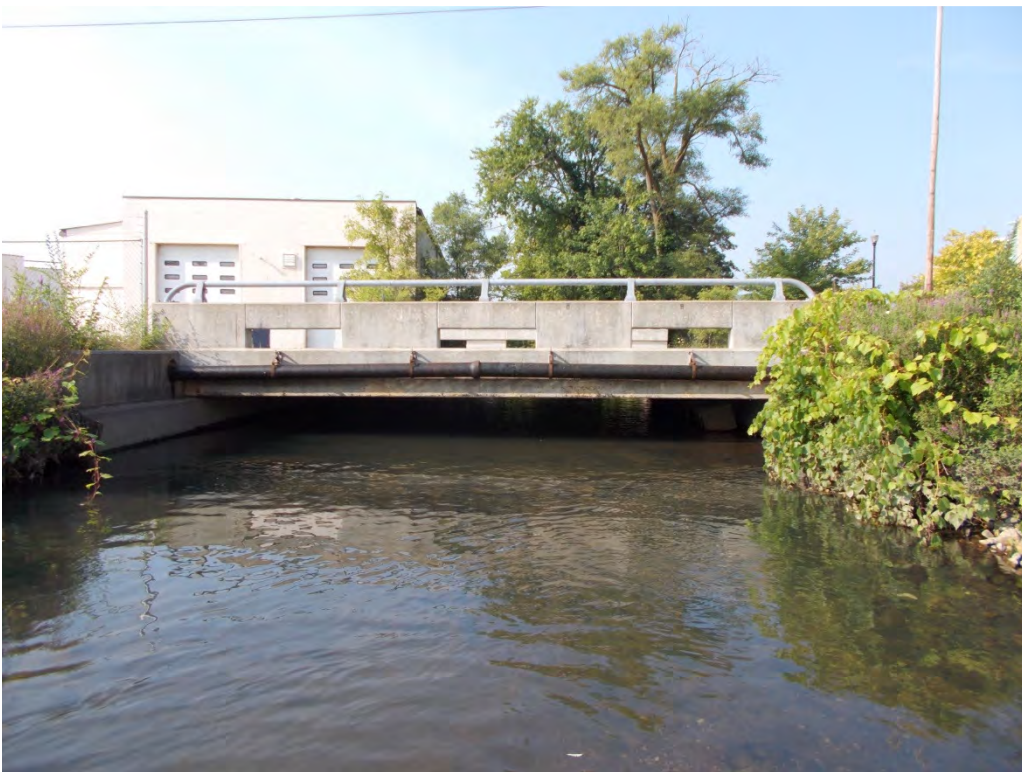
Elevation view of the structure looking south

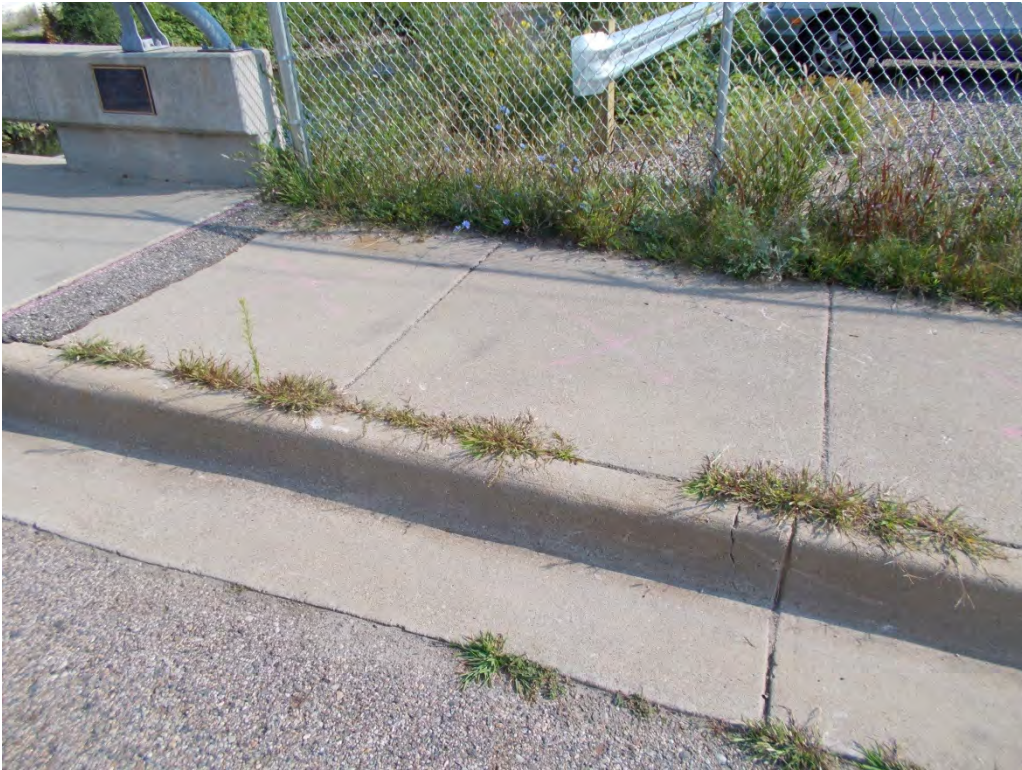
Cracked sidewalk in the northeast apparently painted for removal

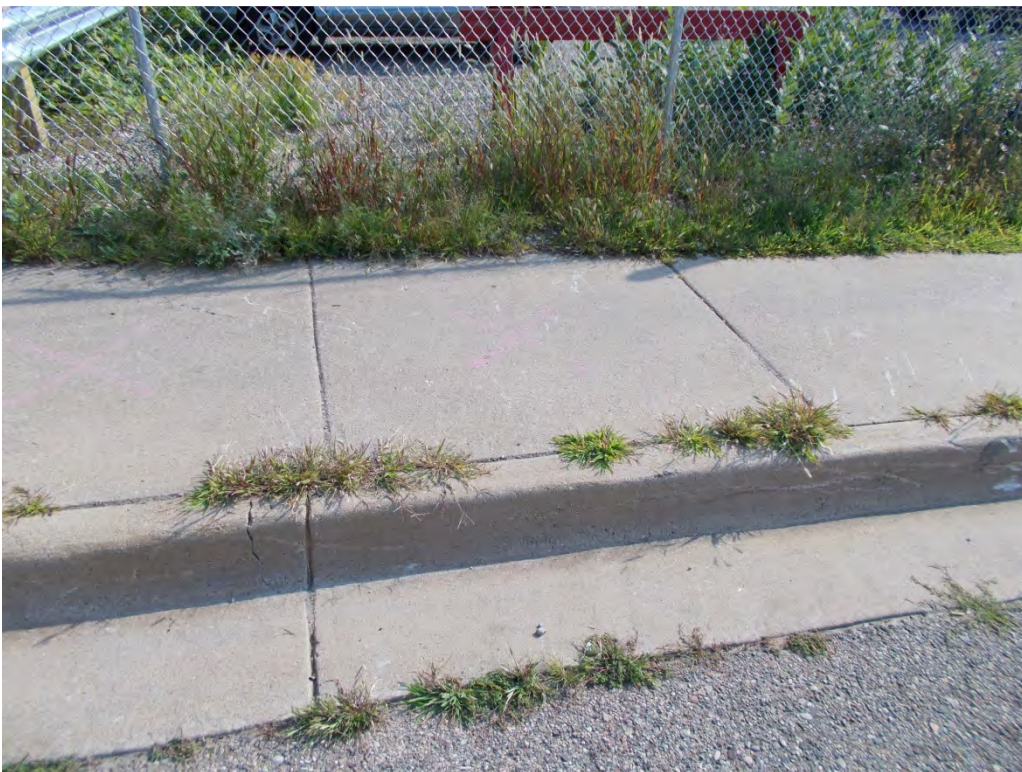
Cracked sidewalk in the northeast apparently painted for removal

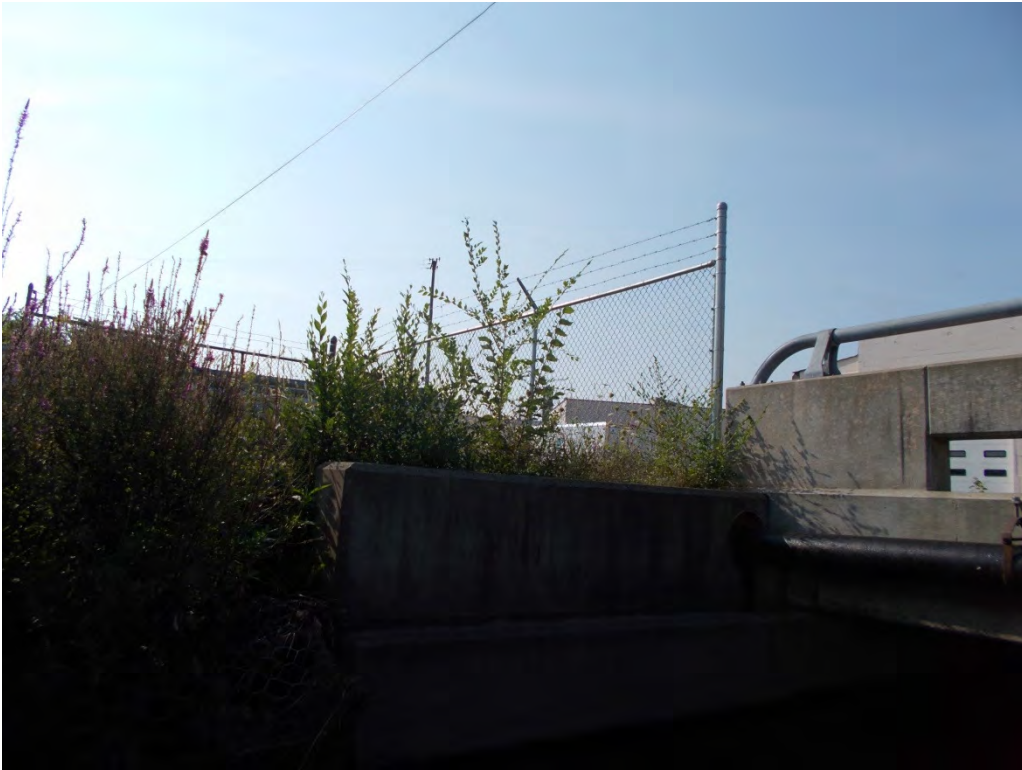
View of fence at Dutton Street from the channel

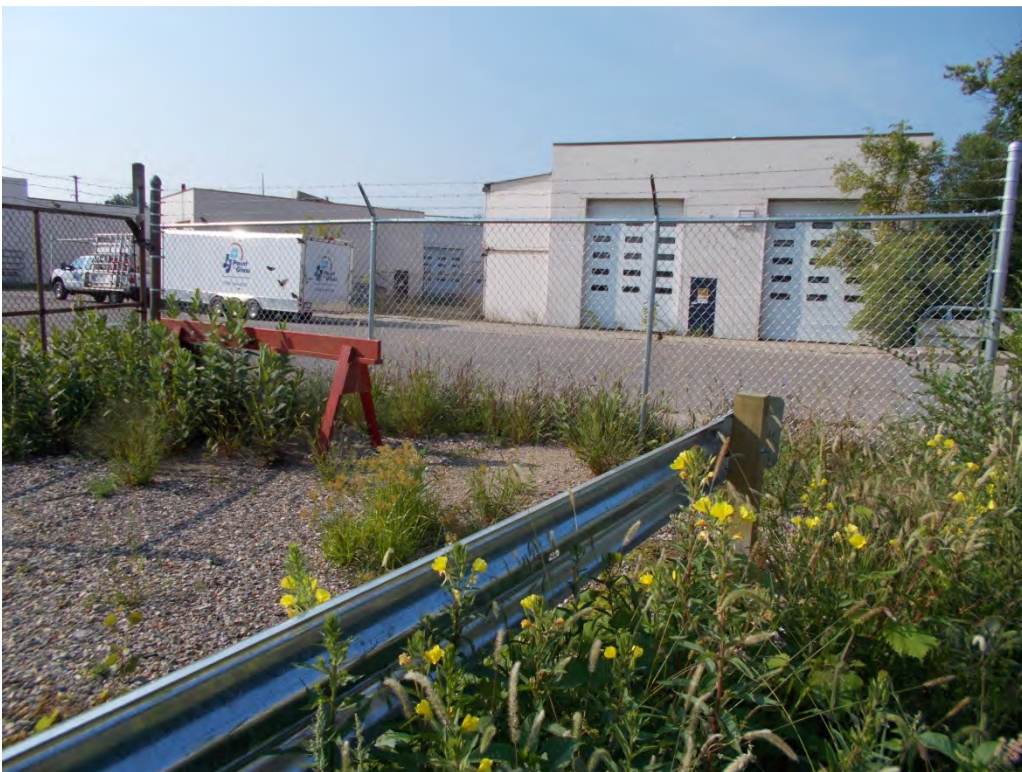
- Several sections of fence at the northeast quadrant of the Dutton Street Bridge have been replaced.
- The fence along the top of bank has been removed and replaced with Type A guardrail. Assuming this was negotiated with the property owner, no additional action is recommended.

View of replaced sections of fence along Dutton Street

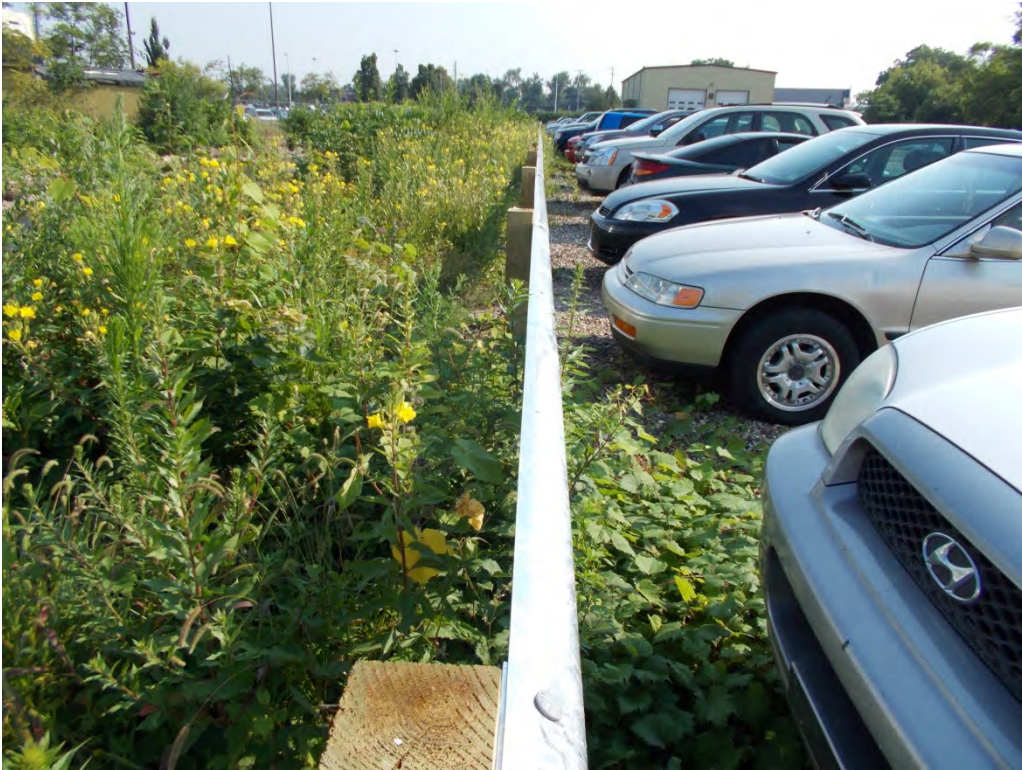
View of new Type A guardrail along top of bank

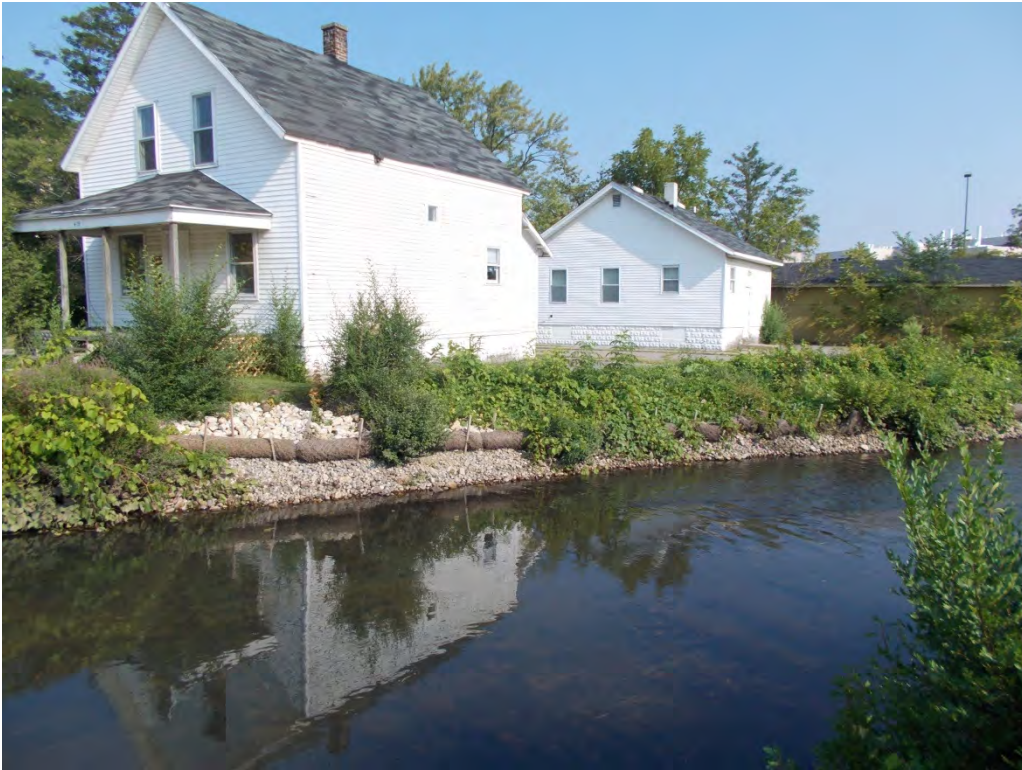
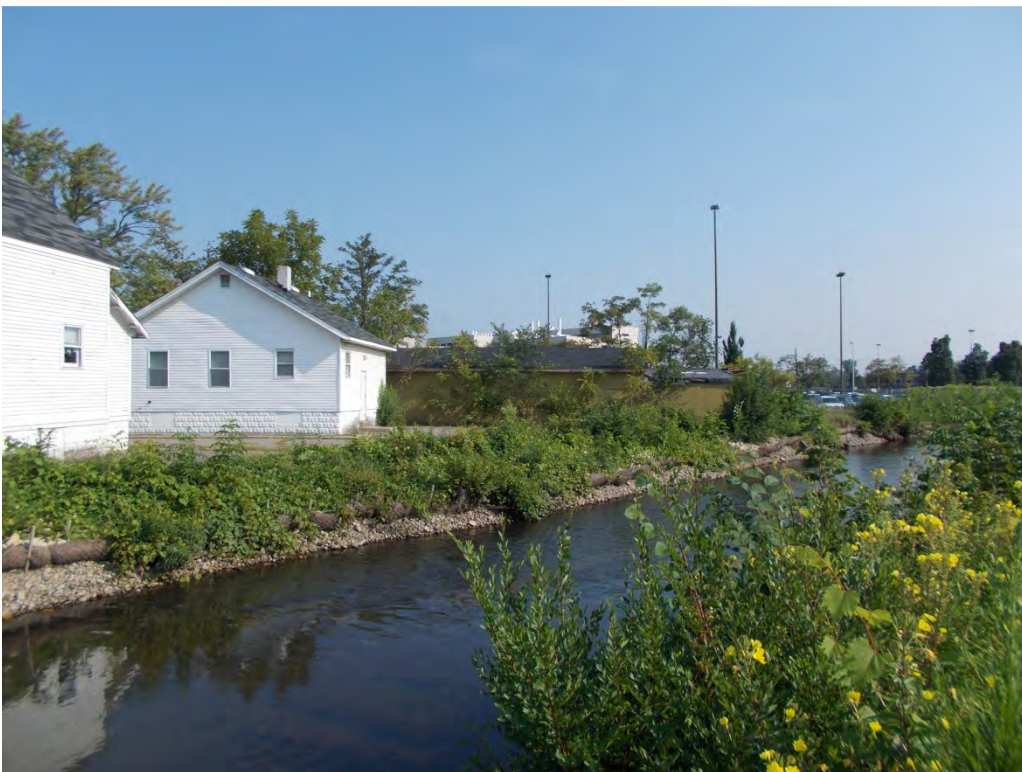
- The fencing has been removed. Assuming this is acceptable to the property owner, no additional action is recommended.

View of the west bank in the area of the previous fencing

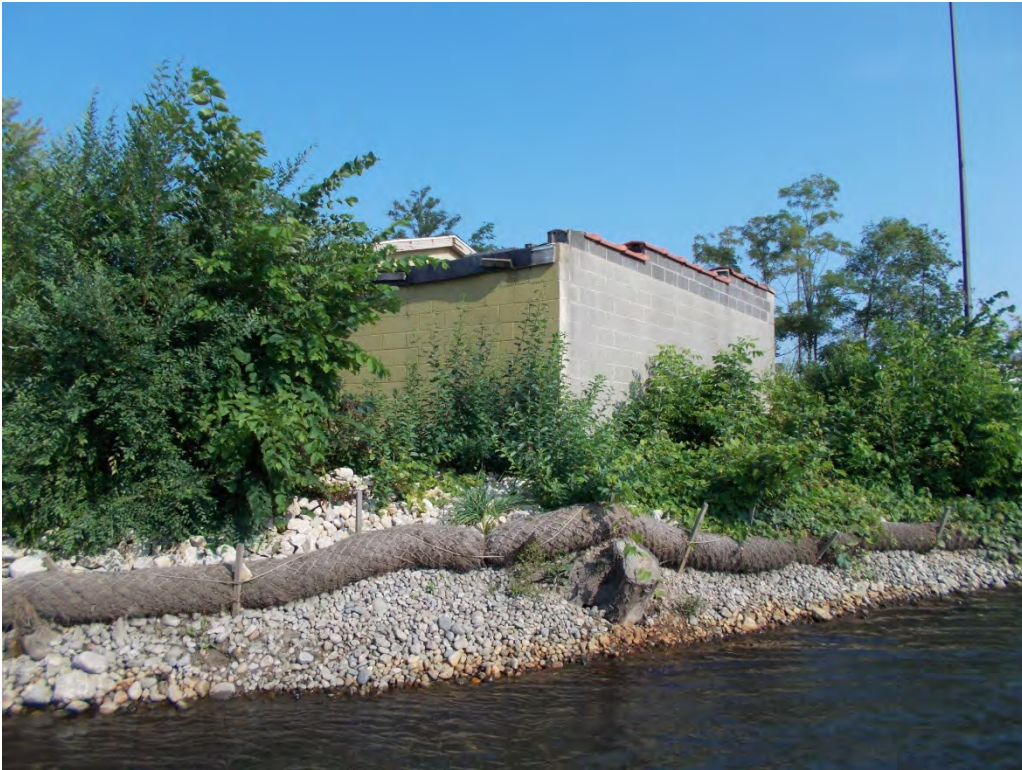
- Fencing adjacent to the building has been removed. Assuming this is acceptable to the property owner, no additional action is recommended.
- The structure itself does not appear to have been impacted during sediment removal.

View of the structure from the upstream channel

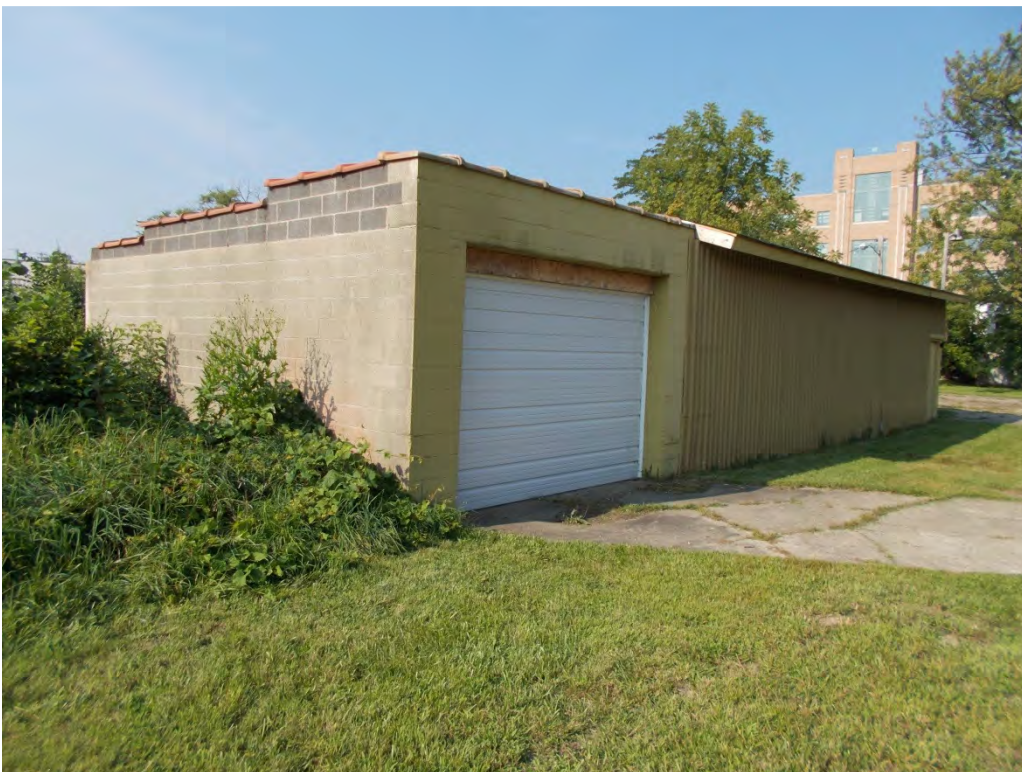
View of the structure from the downstream bank

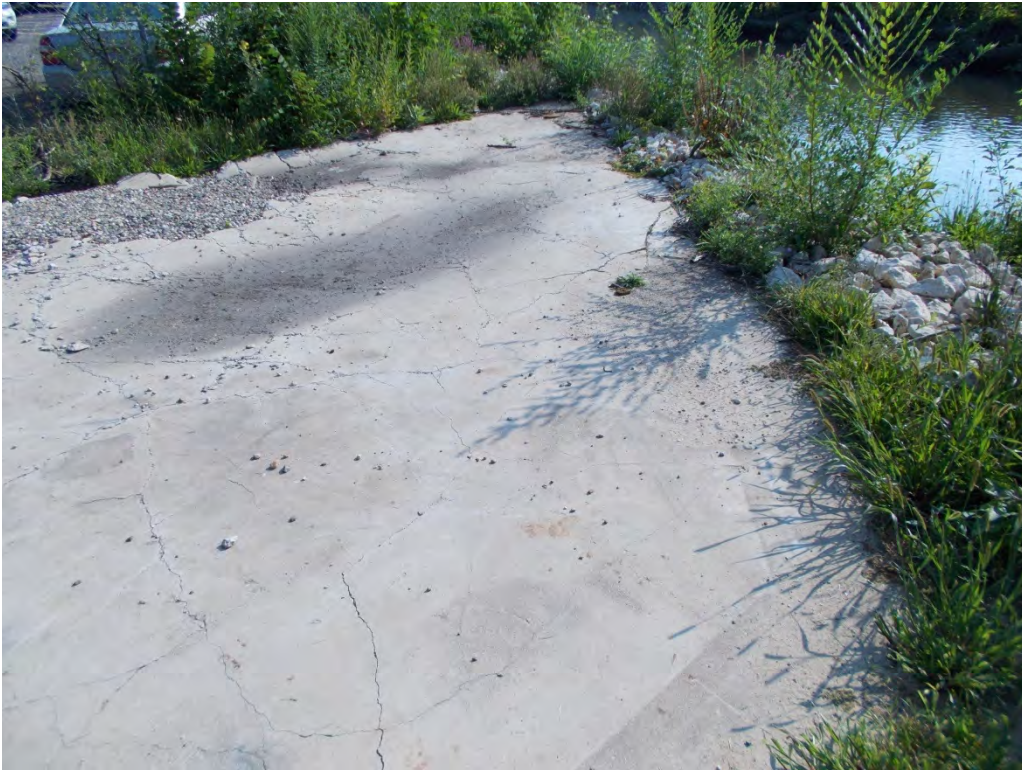
View of slab looking north

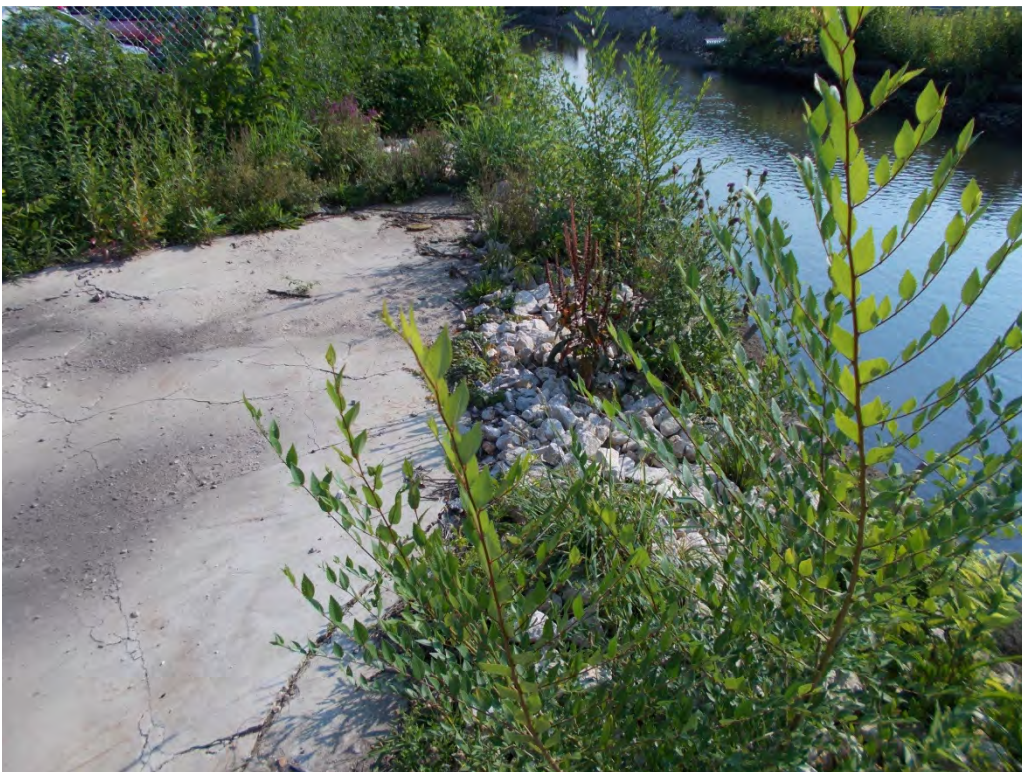
- Riprap has been placed along the creek side edge of the slab.
- Although the slab was in poor condition prior to sediment removal, it appears that sediment removal operations have worsened its condition. If not already done, it is recommended that the property owner be contacted for direction.

New riprap along east edge of slab

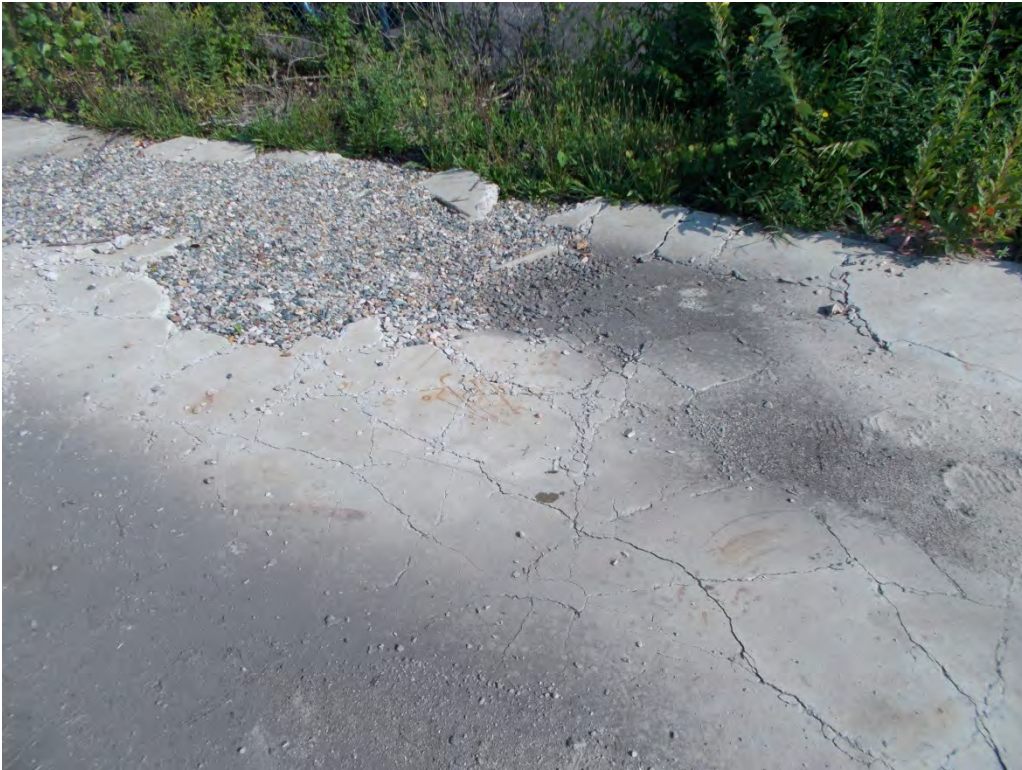
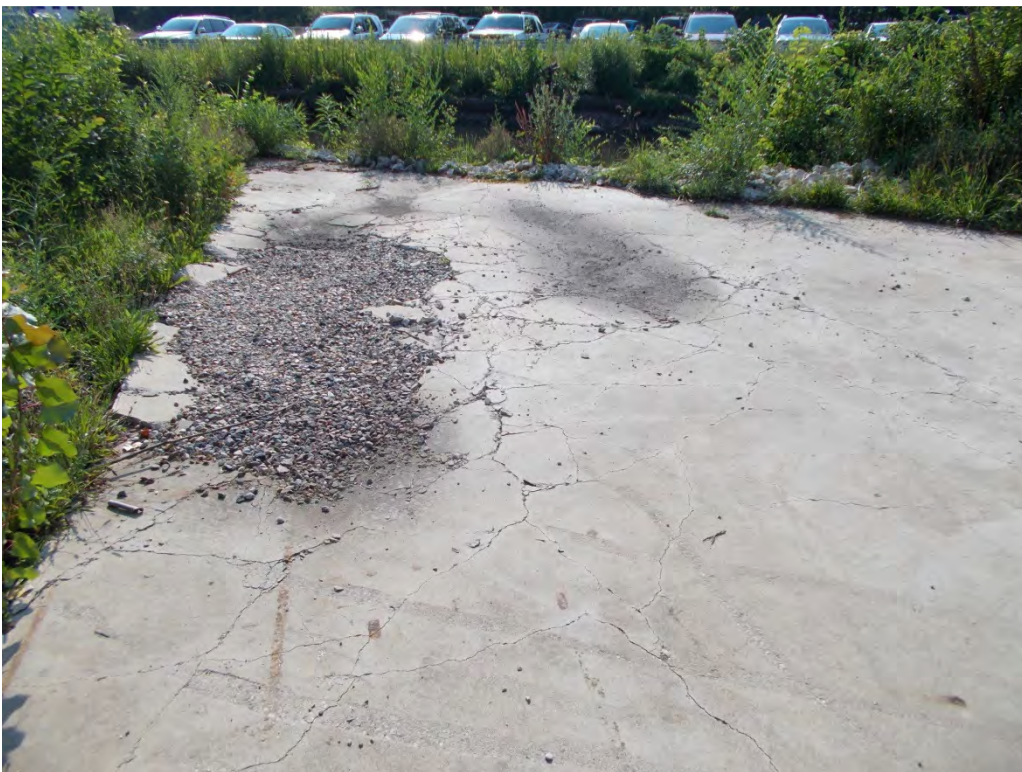
Severe cracking, spalling and settlement of north side of slab

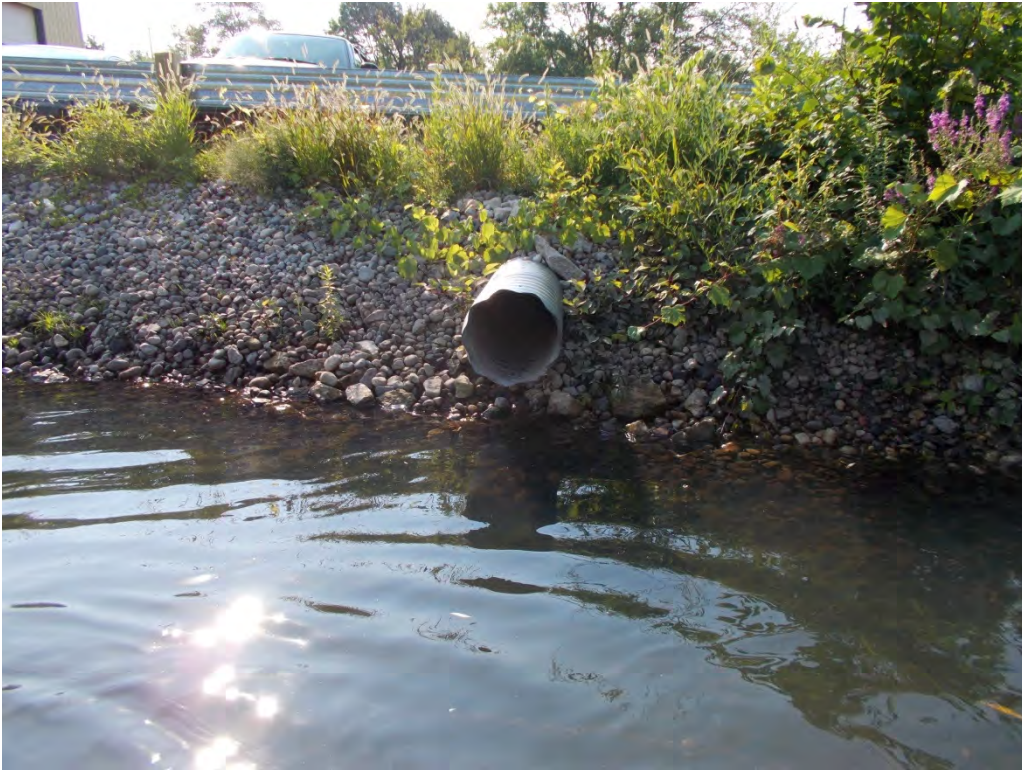
- The outlet has been replaced with a new CMP outlet.

View of new outlet from channel

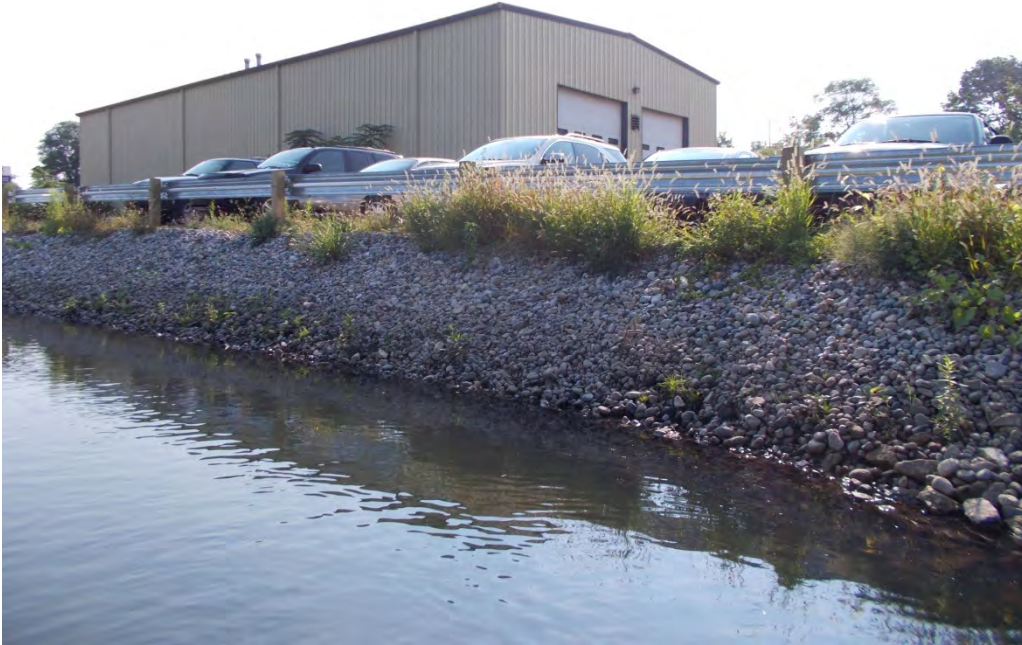
- The structure has been removed and replaced with Type A guardrail. Assuming this is acceptable to the property owner, no additional action is recommended.

View of bank and new guardrail in the area of the previous structure

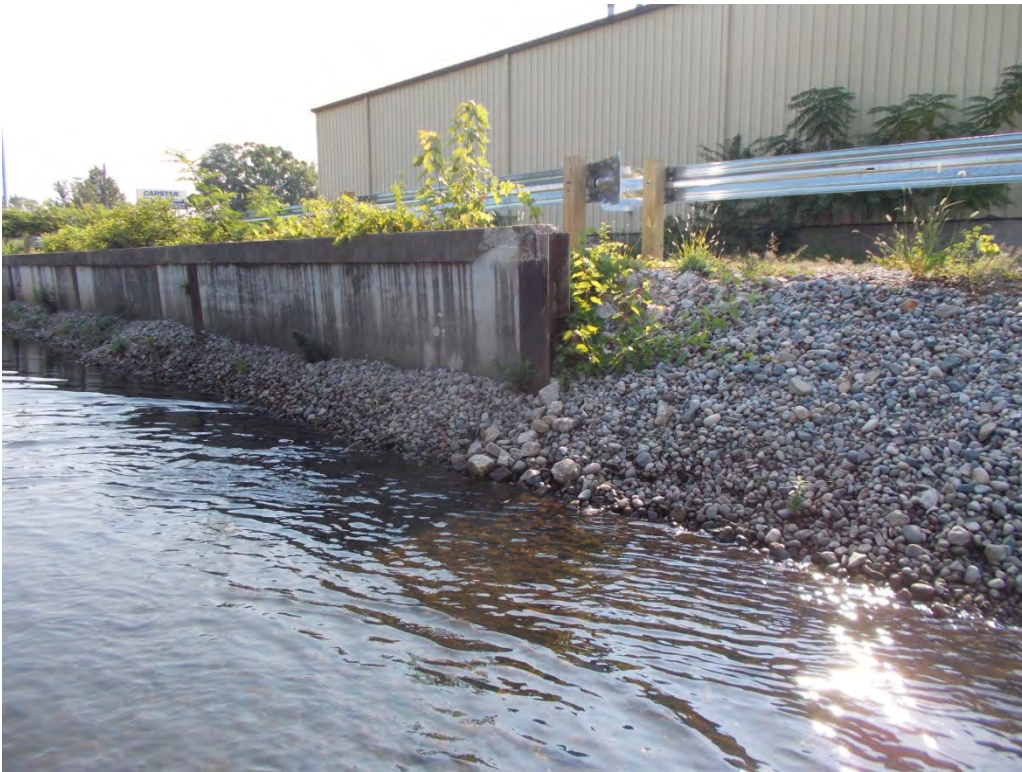
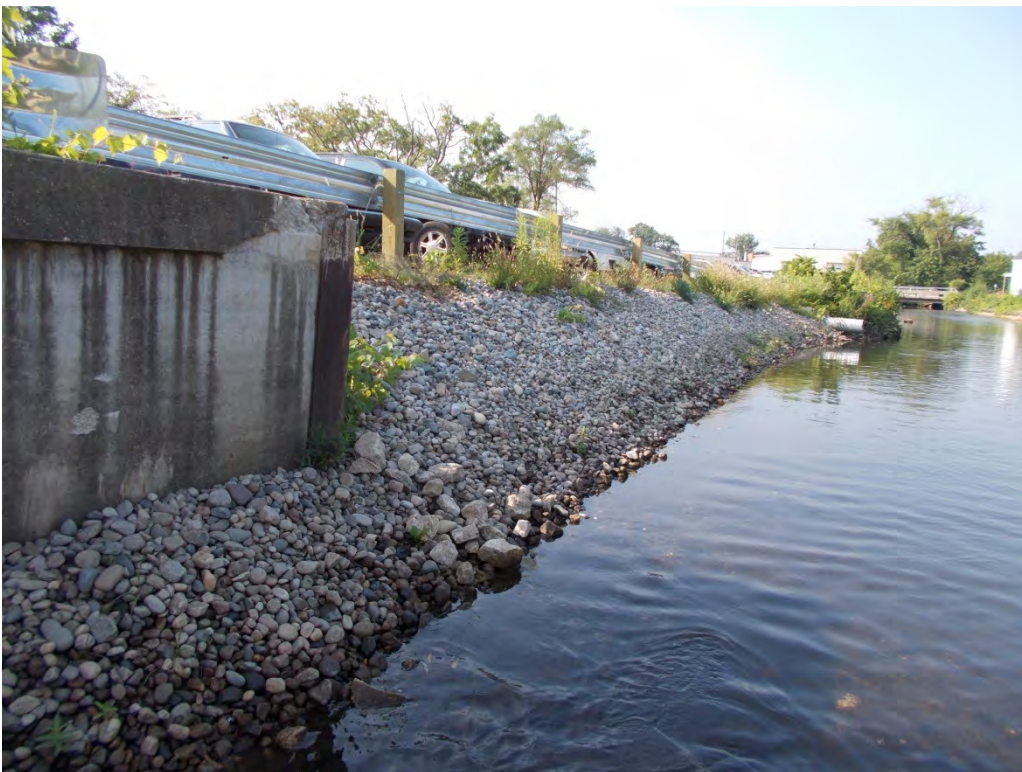
- The failing south end of the structure has been removed and replaced with a stone bank and Type A guardrail. Assuming this is acceptable to the property owner, no additional action is recommended.

View of south end of the structure looking north

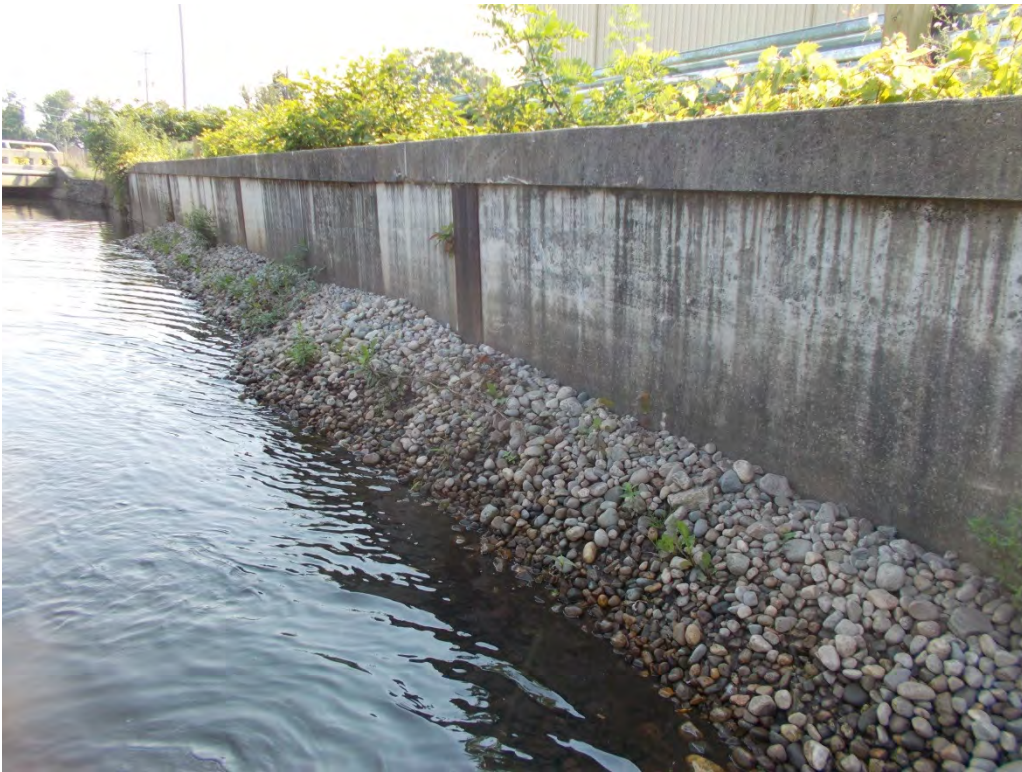
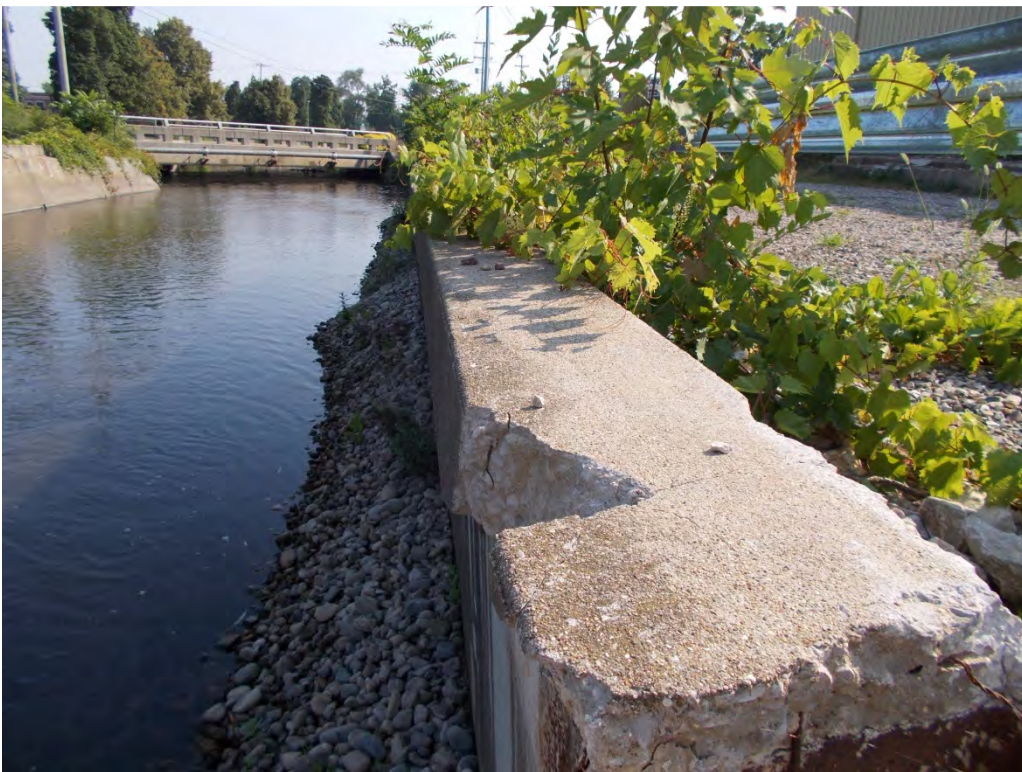
View of the structure looking north

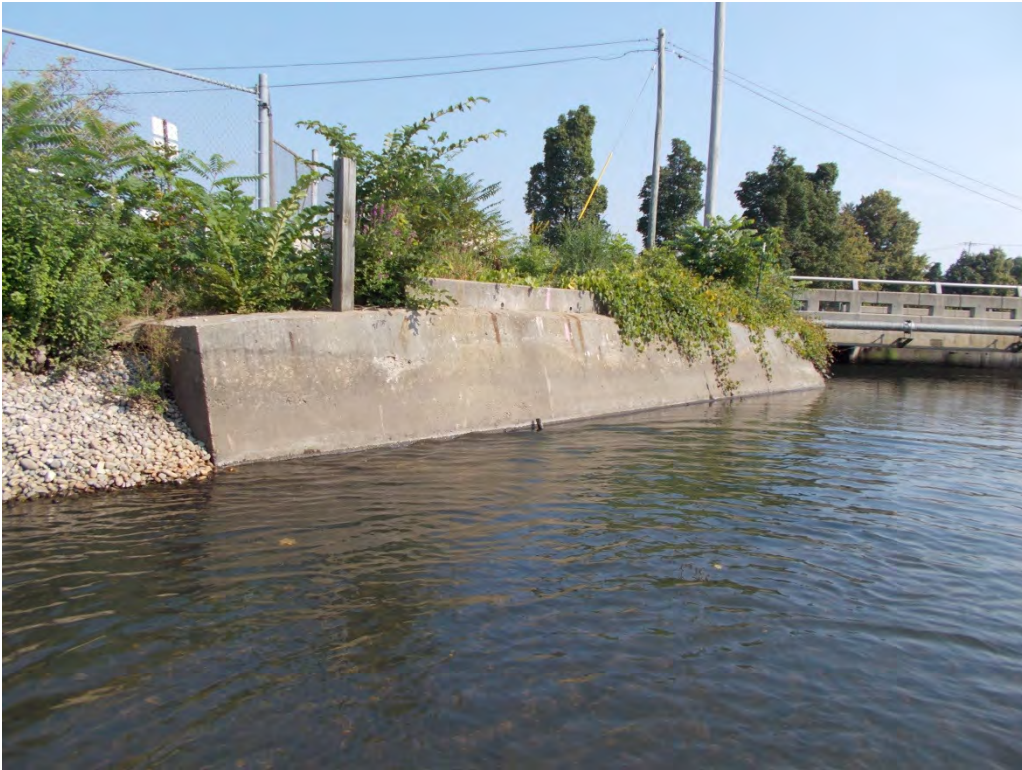
- The structure does not appear to have been impacted during sediment removal.

View of the structure from the upstream channel

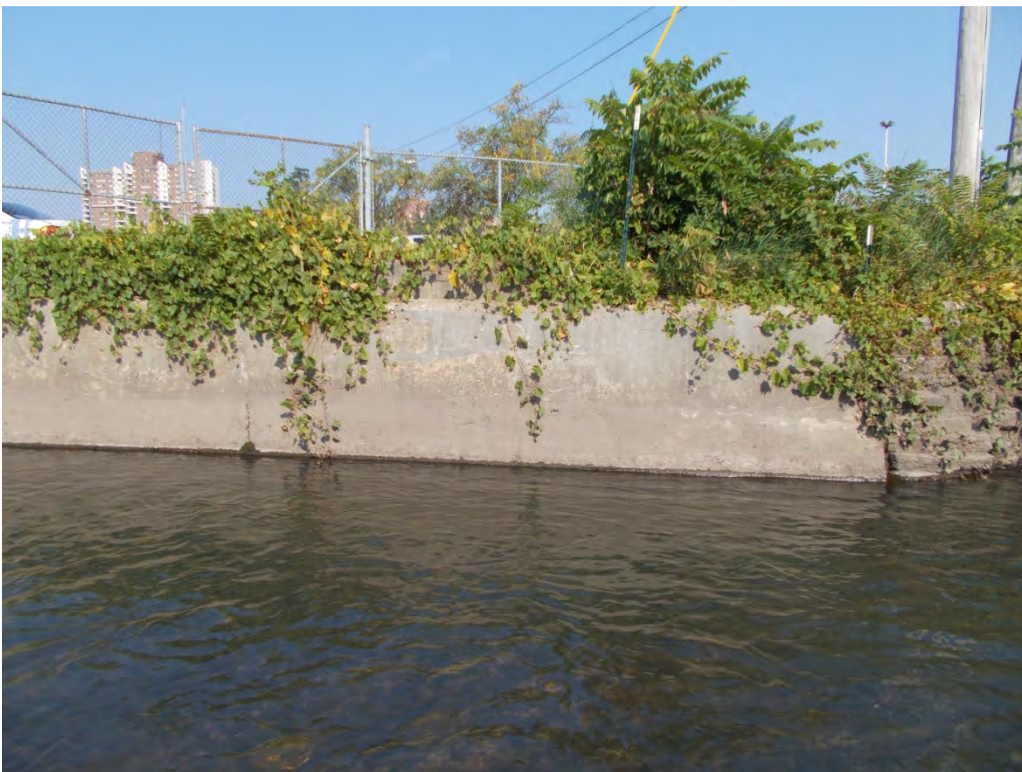
View of the structure from the channel

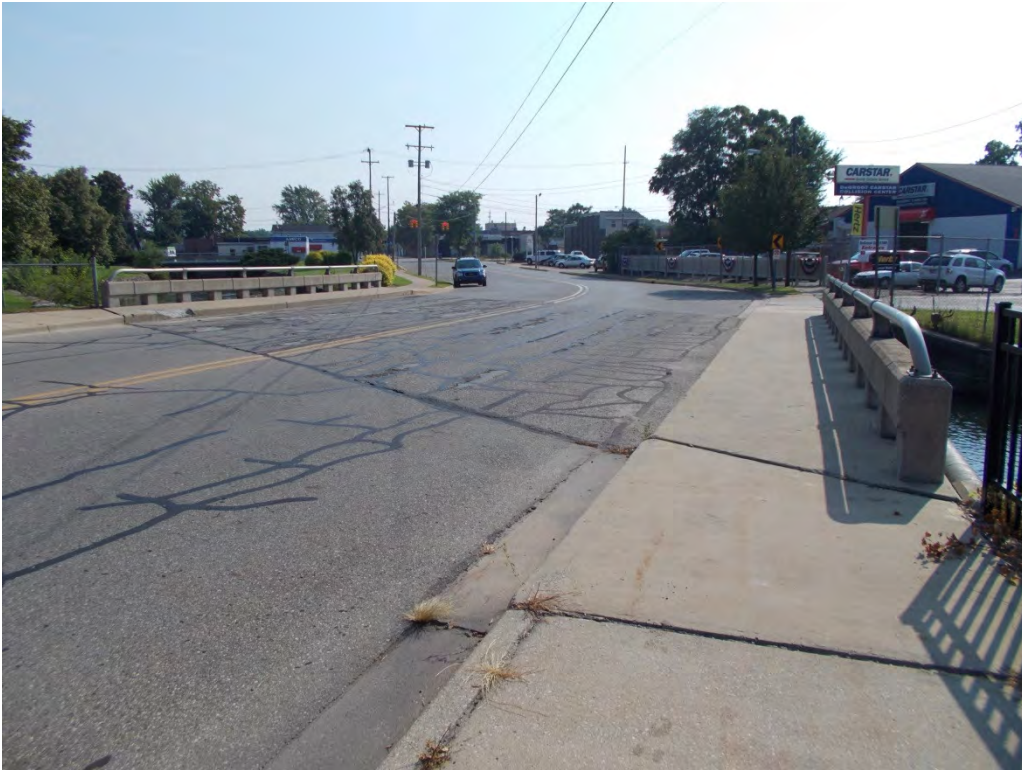
View of structure from southwest approach

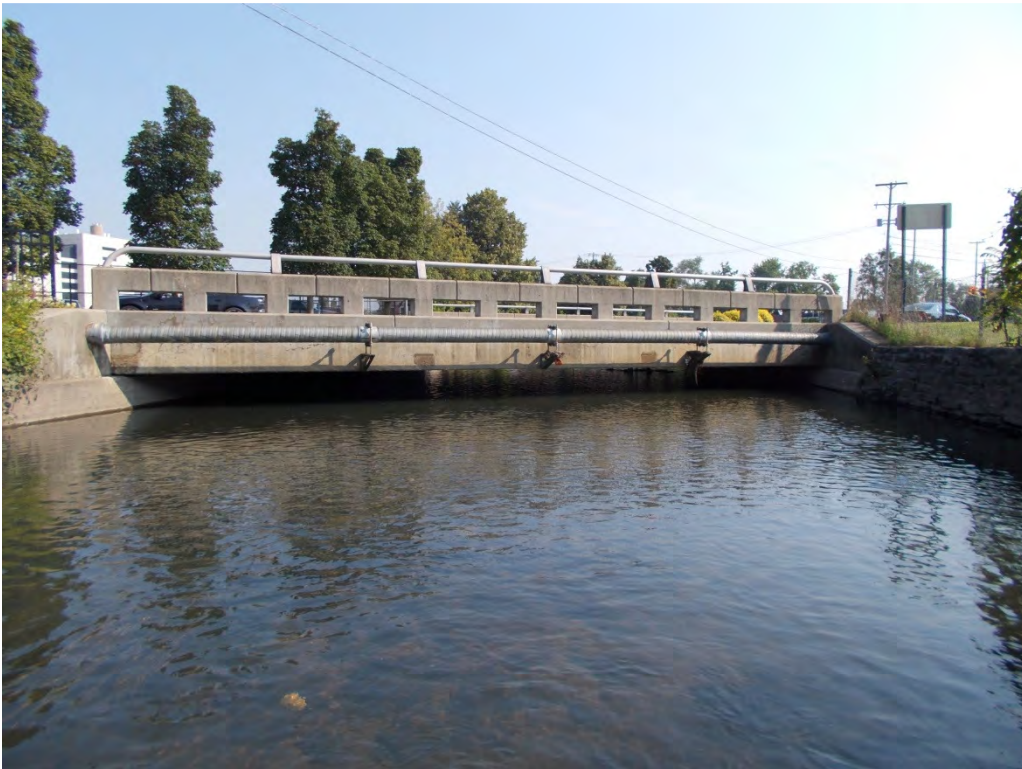
Elevation view of structure from upstream channel

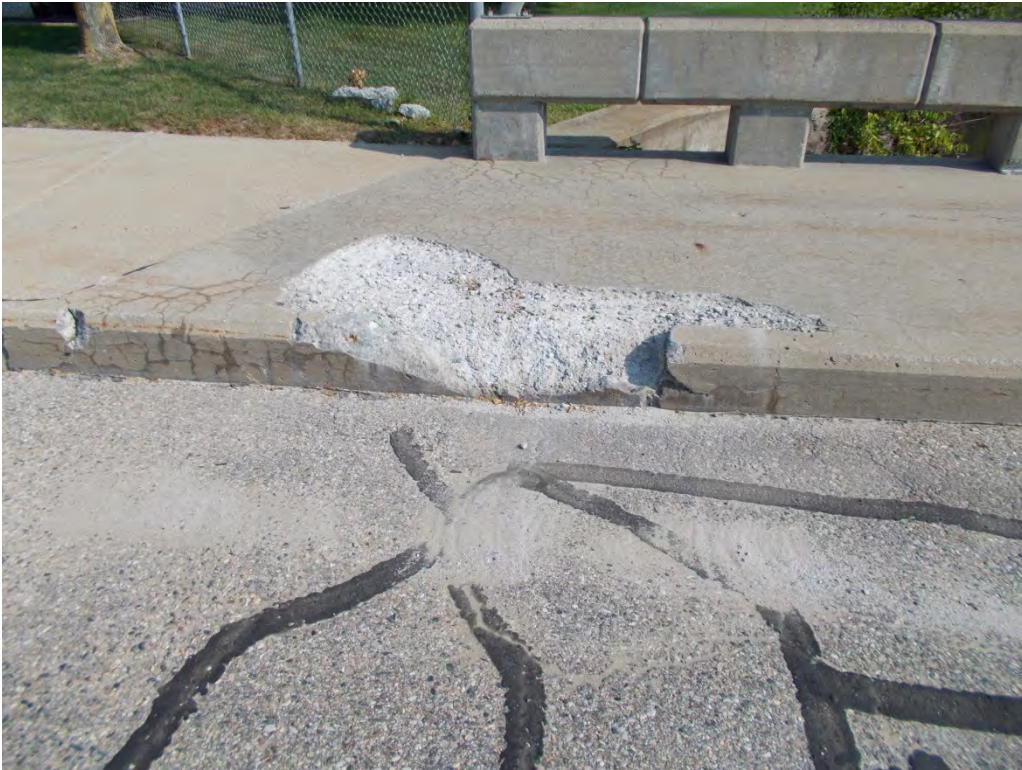
- Spalling on the sidewalk in the northwest quadrant of the structure is significantly worse than it was during the Pre-Sediment Removal Structure Feature Assessment, however, no evidence was noted indicating that the damage was related to sediment removal operations. It is likely that the damage resulted from freeze/thaw patterns over the winter months.
- The structure does not appear to have been impacted during sediment removal.

Sidewalk spalling in the northwest area of the structure.
